Manhole Inspection Summary

Manhole # S43G__017MH

Insp Date: **6/3/08 10:04 AM**

Location Address: **232 broadway st**

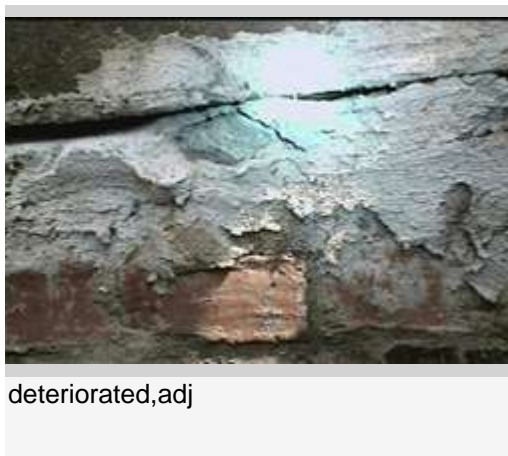
Defect 1

Condition: ☐ Sound ☐ Cracked ☐ Root Intrusion ☐ Loose Brick ☒ **Deteriorated**

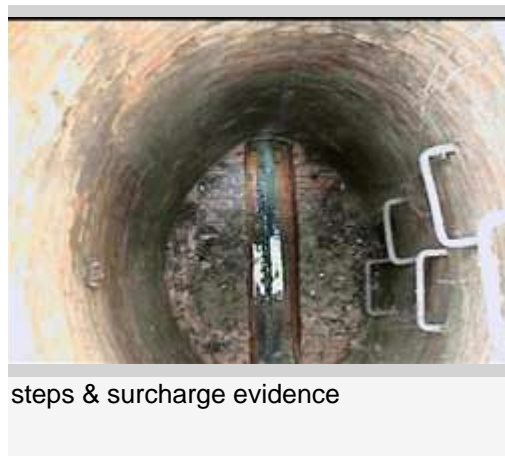
Defect 2

Count: **6** Missing: **0** ☒ **Corroded**

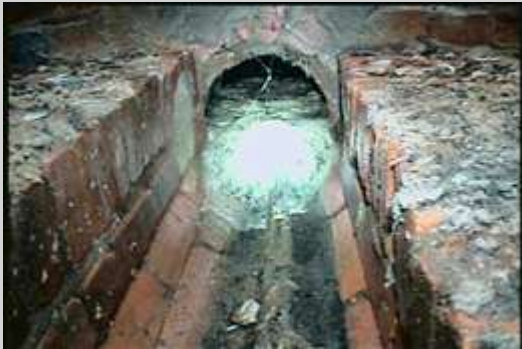
12 O'Clock Outflow

8 in. Circular Gravity Sewer
Pipe Out @ 12 O'Clock

Deposits: ☐ None ☐ Mud ☐ Sludge ☒ Debris ☐ Grease

Silt Depth: 4 (in.) Deposits Extent: Heavy

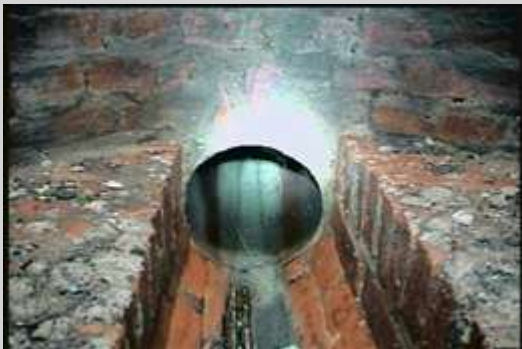
6 O'Clock Inflow

8 in. Circular Gravity Sewer
Pipe In @ 6 O'Clock

Deposits: ☒ None ☐ Mud ☐ Sludge ☐ Debris ☐ Grease
